TEE-ONE TOPICS

Issue 88 August/September, 2009

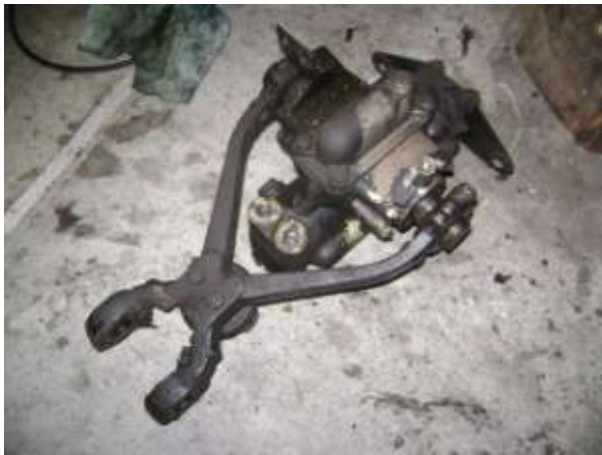
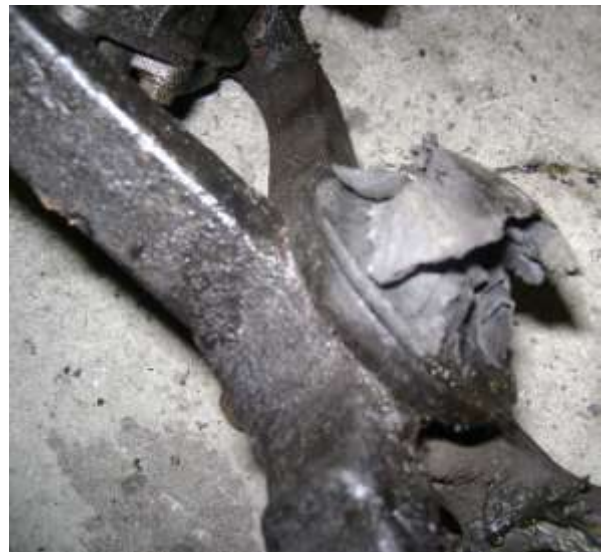
The view at right is one few owners would have of the front suspension of their pristine Silver Cloud. To put it into perspective, look at the following.

The mangled mess of rubber above is bolted to the arm of the front shock absorber seen the right way up at the left. This rather pretty S2 had skittering suspension (I know – horses skitter but so did this car if it hit a sizable bump) which was fairly obviously

traced to inactive shock absorbers. New units are no longer available. Even if they were, the last price heard was over £2000-00! Fortunately parts to overhaul them are still available and they can be restored.

Normally one would remove the front spring to remove the shock absorber but as this does require a special tool, supporting the car on the lower wishbone and loading the front end of the car with sandbags until the rubber buffer seen above is well clear of the front cross member, should allow you to remove the unit without removing your head at the same time.

Overhauling the units is detailed in the workshop manual but the work is fairly intricate, often parts will need to be built up and machined and fitting the seals is a task originally devised by the Spanish Inquisition! TK Motors at Moss Vale can do all this for you and the finished product is something to look forward to.

And the rubber buffers? Usually only the top one seen in the picture needs replacing. This is because as with most suspensions the arms are set at nearly their lowest point. When the

wheels hit a sizable bump the load is taken by the spring, the movement dampened by the shock absorber and the reaction of the spring is to slam the suspension down to get rid of its compression. Although the shock absorber dampens this somewhat the poor old rebound rubber cops a fair bashing. If you do not replace the buffer it will eventually fall away and the next decent bump will have the upper suspension arm crashing down on the steel front cross member with a noise that will probably damage your upholstery!

They can be replaced by removing the front wheel and letting the car sit on a block under the lower suspension arm. Weighting the front mudguard with sandbags and compressing the suspension until the buffer clears the cross member, will allow you to unbolt and free the unit. They are still readily available.

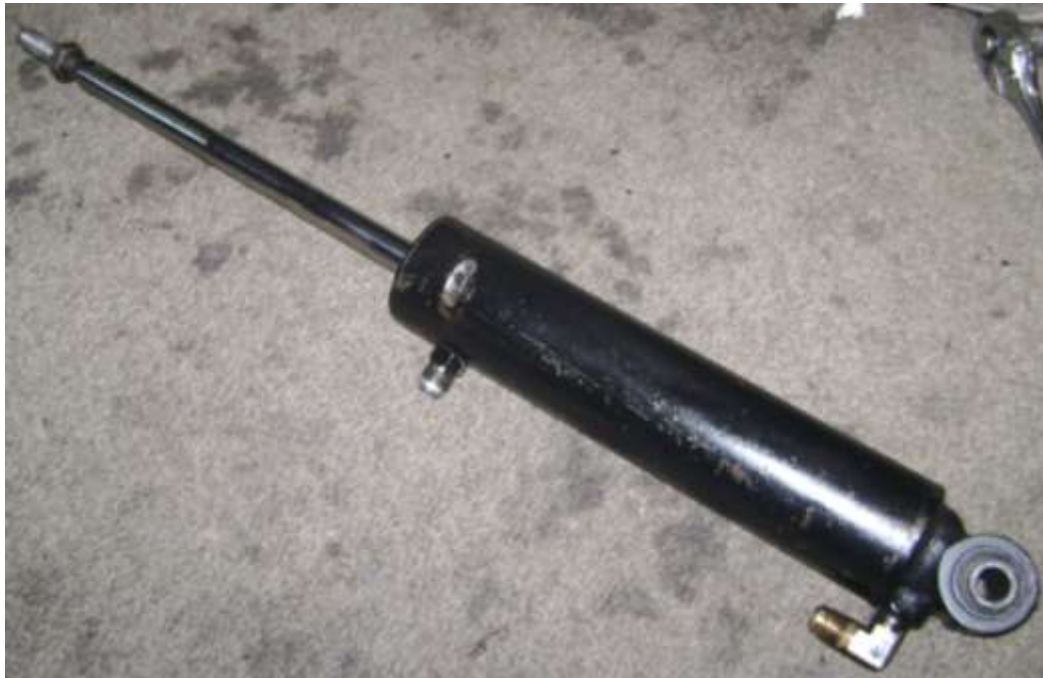
So the picture above is one such ram. Hopefully all owners of post55 cars know where it is, stuck out like a rhinoceros horn and mounted on the front cross member. The initiative in addressing this feature can be seen in the picture above. The body of the ram at the piston end has a nice little groove in it probably with a depth about a third of the thickness of the cylinder wall. This had been worn there by the movement of the antiroll bar which has to

The ram body is mounted along the central axis of the chassis supported solely by a single bolt through an eyelet at the front end and insulated by a silentbloc bush. If you refer to the first photograph you will note the distortion of the bush which was caused by someone running the whole assembly over a curb in all probability forcing the ram upwards and bending the support plates one of which can be seen above. In this case the ram mount was so distorted that the antiroll bar was rubbing on the ram casing hence the groove seen in the first picture!

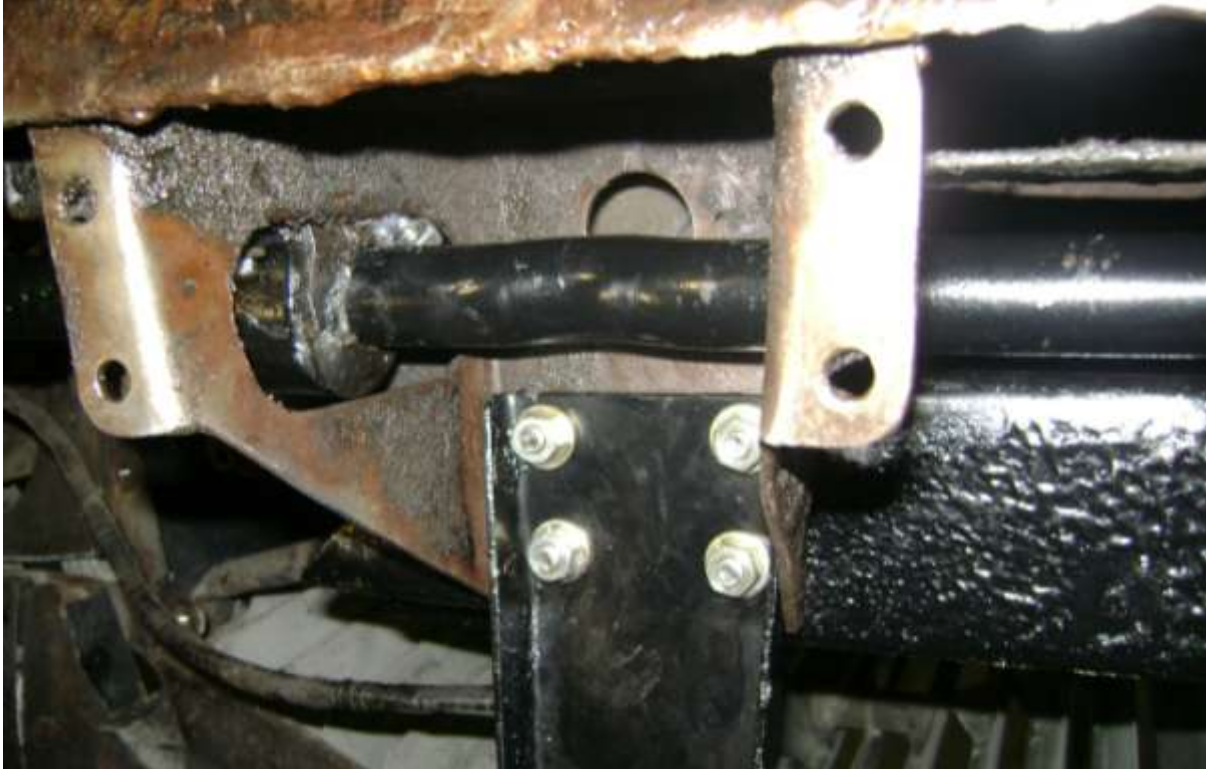
pass over the body of the unit and as can be seen below there is a suitable bump in the bar to accommodate the ram..

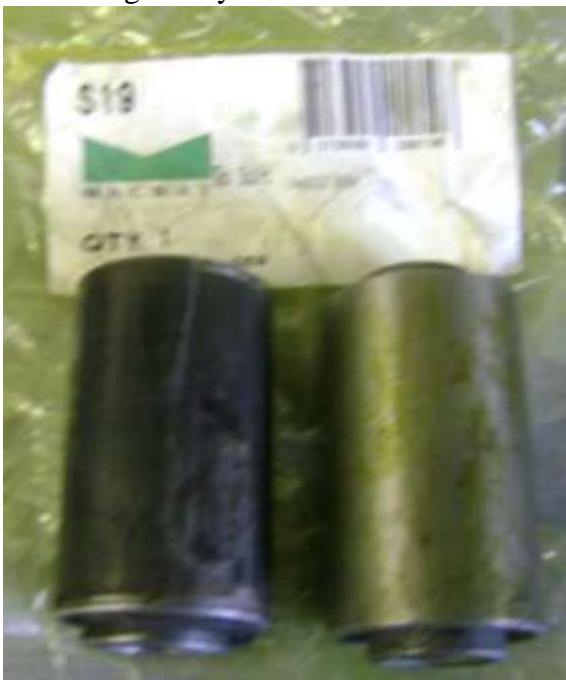
The Ripley Factor. At left is the silentbloc bush pressed out of the front of the steering ram – still available from the Factory – local price AUD237. The item on the right was purchased locally, exactly the same in its packing, price AUD23.

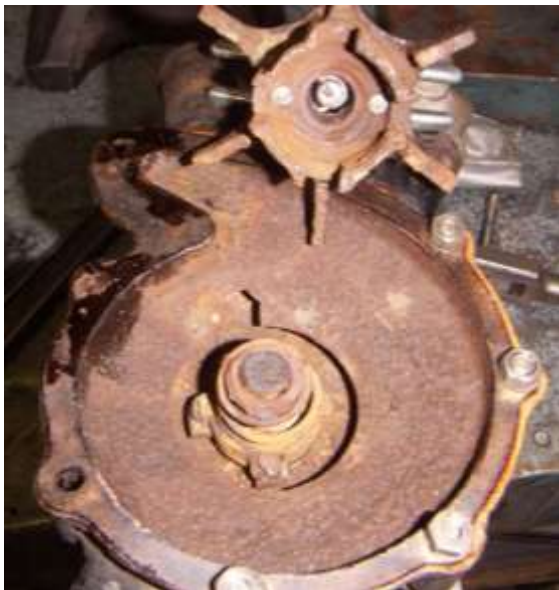
The picture as all of you would have deduced is of the innards of a Mark VI water pump that has seen better days. Fortunately I gather the owner realized that here was one of the many Achilles Heels on any 60 year old vehicle and had the pump checked. To cover any distance with a unit like this would be akin to setting out on a marathon with a fractured radius! The annoying part about these cases is that most if

not all casualties in this category could have been avoided by use of decent anti-corrosion mixes in the coolant.

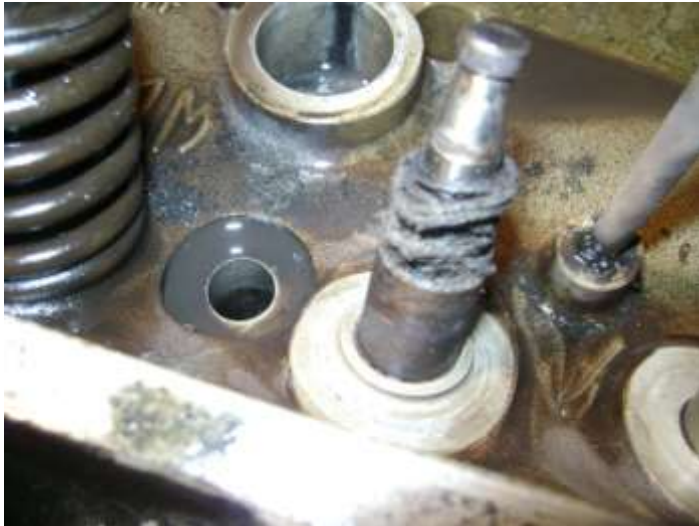
These little but very important bits of the engine have been a source of much discussion among owners for many years. The original seals seen here as some coiled string around the valve stem consisted of cord impregnated with graphite, wound into a suitable tube shape and compressed by springs to take a firm grip of the valve stem and minimize the flow of oil down the valve guide and into the intake air stream!

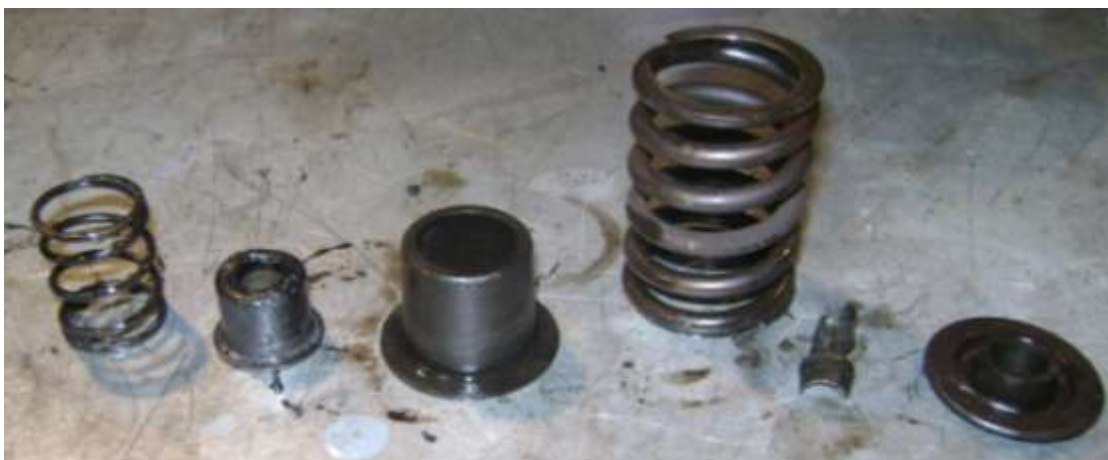
The bits above were removed from the valve in the first picture. The 'top hat' and smaller spring at the left, fit over the old seal and the top of the valve guide, these in turn are held down by the larger 'top hat' which also has the job of holding the bottom of the valve main spring in place. The last two items are the spring cap and the little collets that fit in the groove at the top of the stem which can be seen in the first picture.

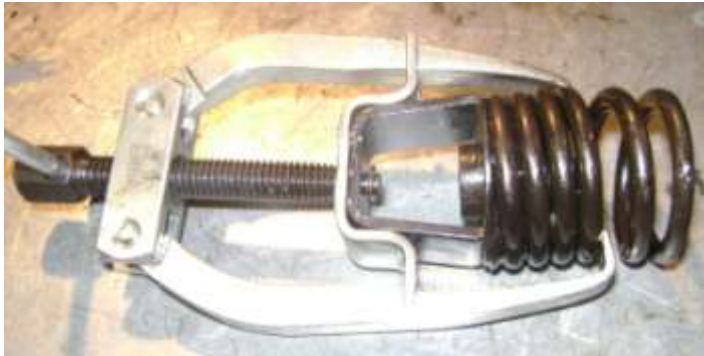
At left is the tool now used for removing valve springs. The legs that grip the coils are offset to allow for the coils and the cap is pushed down by an adjustable saddle seen here.

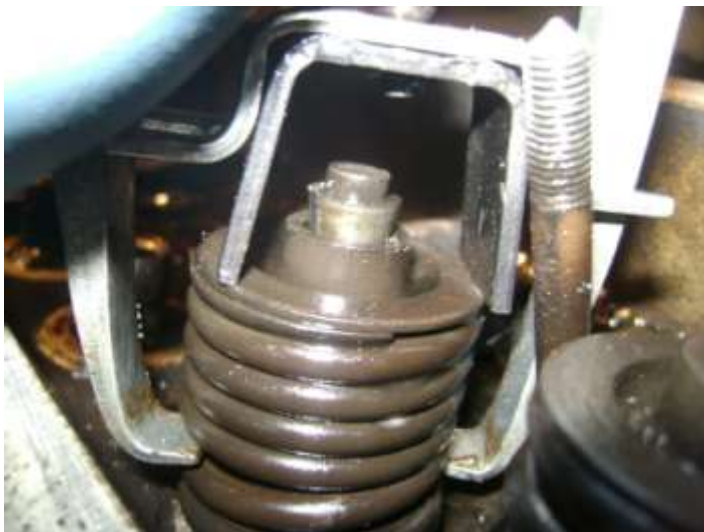
At left is a spring compressed and pushed down the valve stem to reveal the two collets waiting to be plucked to security

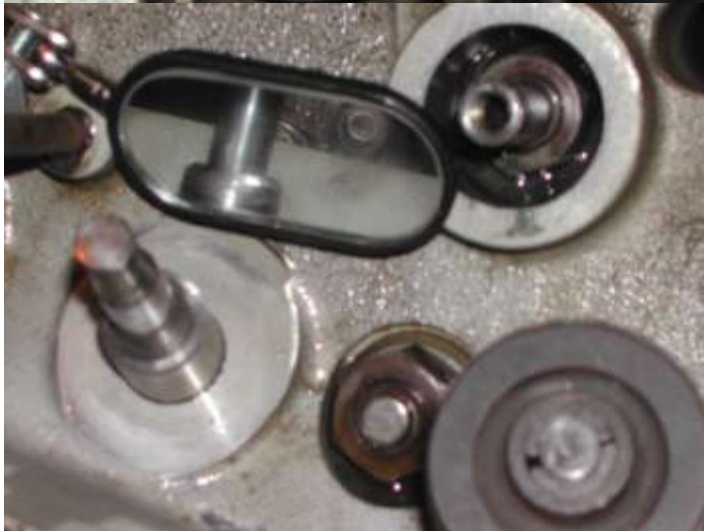
There are several types of seals now available, the most favored appearing to be ones that fasten over the top of the guide and held in place by friction. On this occasion an American seal consisting of a light metal cap with a captive flexible seal in the aperture was used. The body of the seal is a tight fit and requires driving on with a special applicator and a hammer. To avoid the seal wall picking up on the sharp upper edge of the guide the edge of the latter is chamfered with a tool. The result is shown at left.

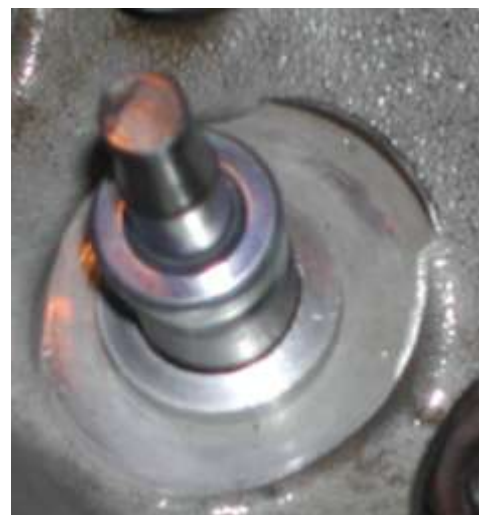
At right can be seen a locating ring that is placed over the guide which is made up to replace the original small 'top hat' since that item and its spring has no function with the new seal. The 'rim' of the discarded

'hat' was designed to keep the larger 'hat' concentric to the valve and stop the spring slithering around on the head. The locating ring now in place does this job and keeps the large 'hat' in place. Here the new seal has been pushed over the valve stem and onto the top of the guide. This requires a thin plastic cap over the valve to avoid any damage to the seal as it crosses the sharp edges of the collet groove.

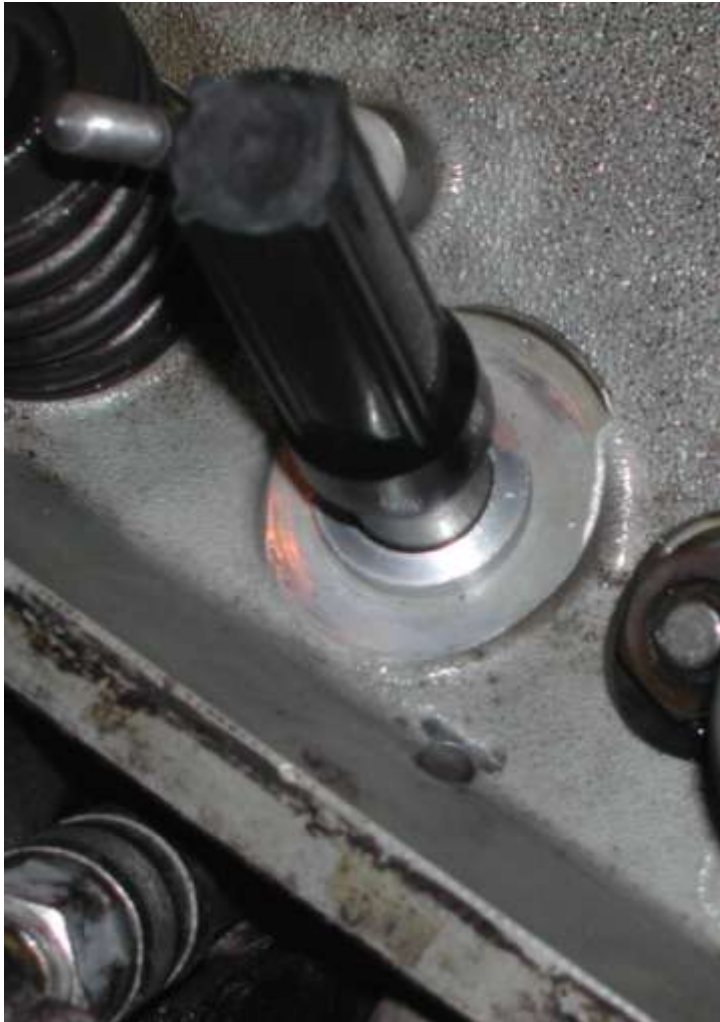
At left is the simple plastic tool to drive the new seal over the end of the valve guide. All that remains is to reinstall the main valve spring on its 'top hat', the retaining washer and the valve collets.

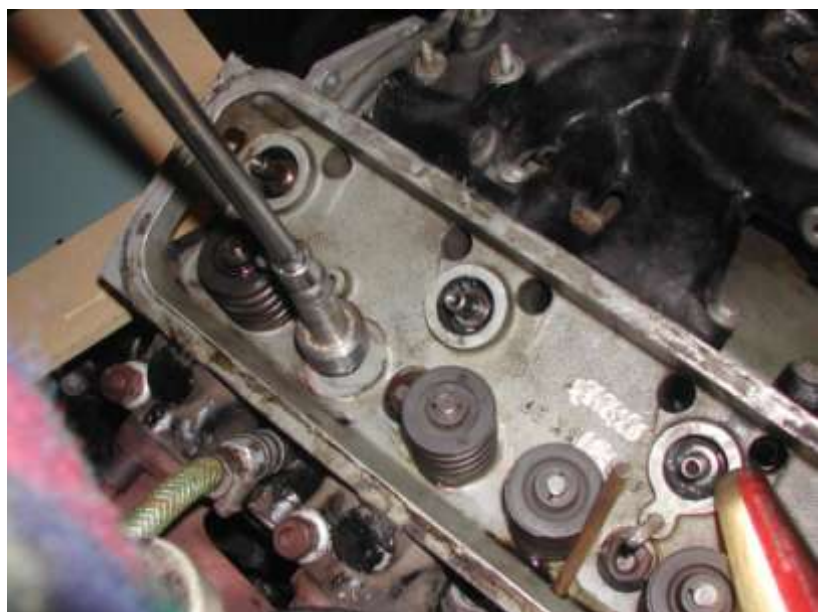
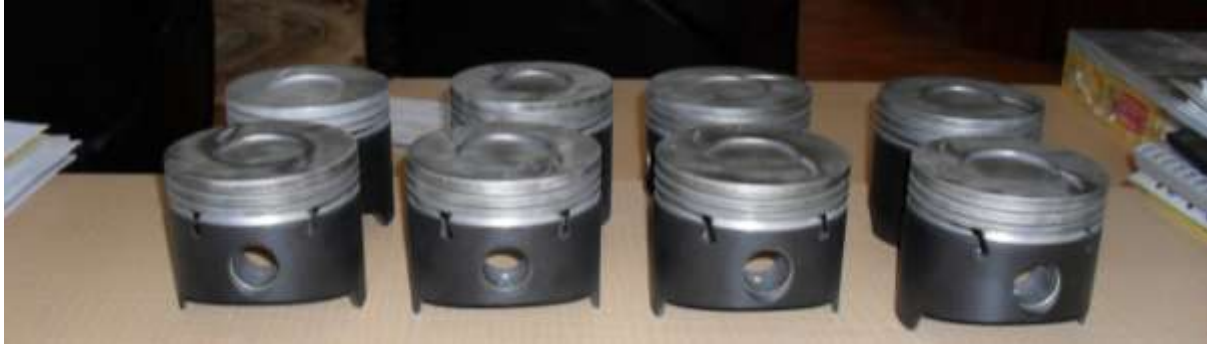
Below is the chamfering device in action. The tool has a small hardened bit ground to the angle required to cut the top of the guide. The lower picture was taken of a Phantom VI engine and the seals were installed with the cylinder heads in situ.

The hose and adapter seen at right supplied 100 psi of compressed air into the cylinder being worked on obviously with the piston at top dead centre and both valves closed. This is necessary as the valve has to be closed fully to get the collets in place. Valve retaining tools can also be made up and poked through the spark plug hole. If compressed air is used you will need to wedge

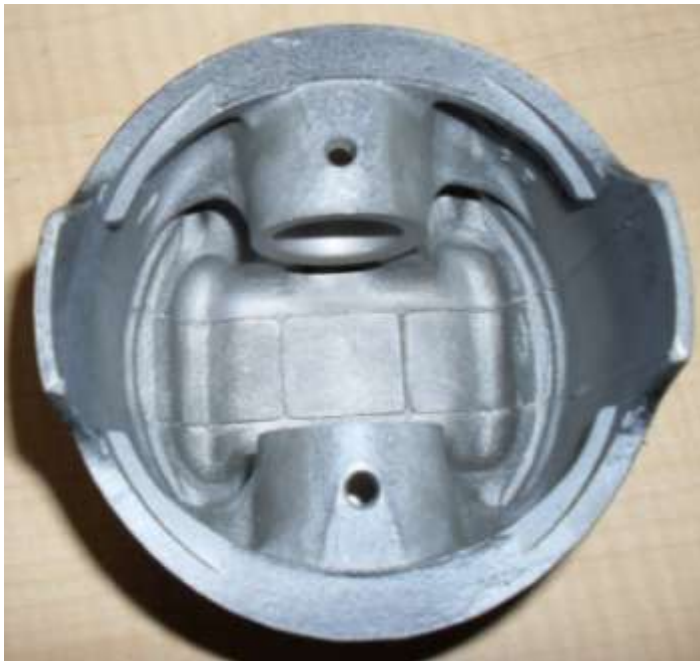
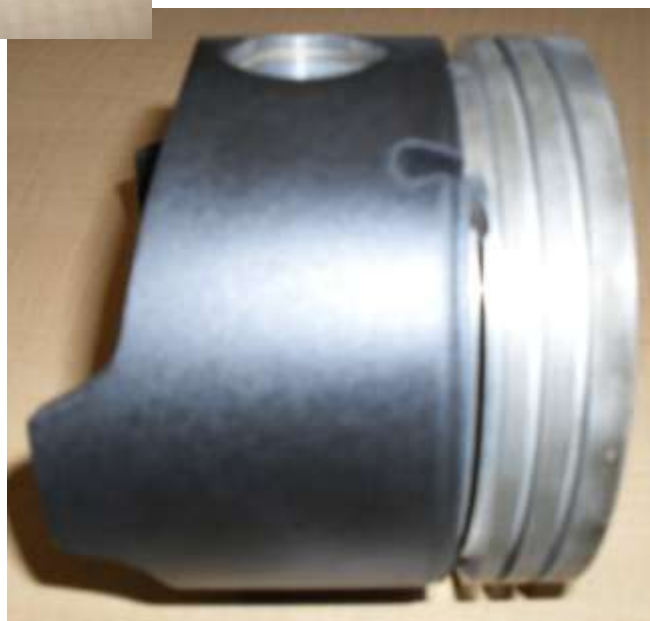
The Great Engine Rebuild progresses! The pistons on this '72 Shadow engine were still very serviceable and the liners had barely measurable wear in the bores. In the aggregate there was about a thou (.001") more clearance between the piston and the liner than desirable so the liners and pistons were shipped off, where the former were honed and the latter were Teflon coated. This was all new to me but I am assured it is the modern approach and very effective.

While the pistons were being doctored the ring grooves were cleaned out and the bottom oil

ring groove enlarged to take a more modern item.

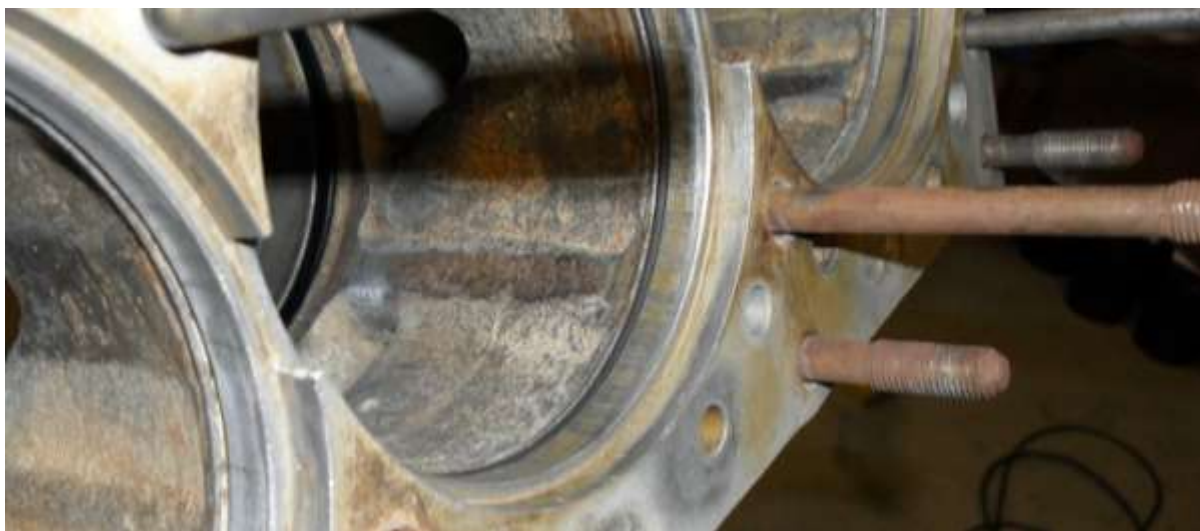
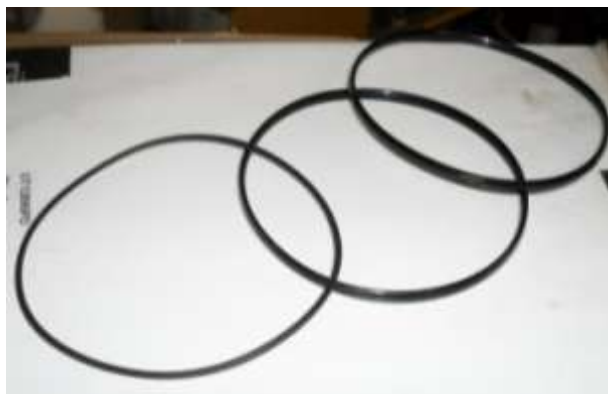
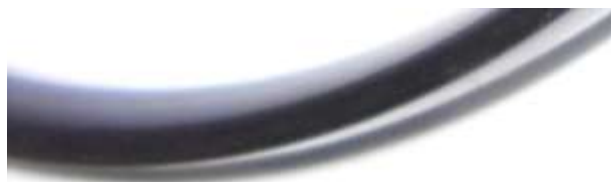
Above is the naked block showing the top 'O' ring installed in its groove and at the bottom can be seen one of the two rings to seal the cylinder liner in the block. The 'tell-tale hole' is between these two lower seals.

At left are the three seals. The thin one appears to be a common 'O' ring that seals the top of the liner, while the lower seals are almost diamond shaped in cross section and with a very smooth surface. The bottom picture is my attempt to picture the shape of the lower rings. Instructions are that these be placed in the groves with palmolive grease which translates to good old Vaseline.

Given the vagaries of the casting, the careful application of a good gasket sealant in the groves before the seals are inserted seemed at the time to be a wise move. The moment of truth will be in the running.

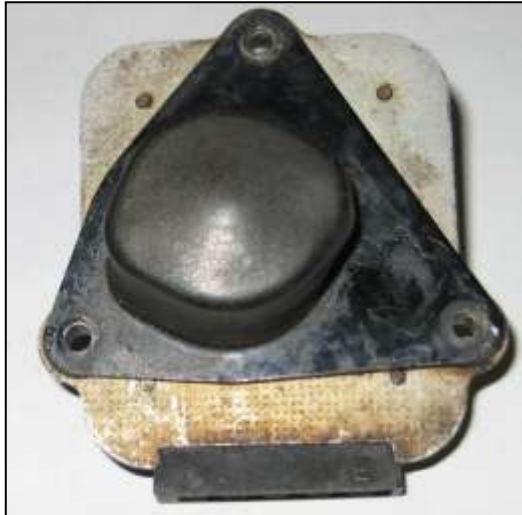
At left is a familiar view for those that deign to open the bonnet. The actuators are rotary switches making their break and no break connections by means of a segmented disc rubbed appropriately by spring contacts.

The rotary disc is turned by a tiny electric motor which is empowered by an intricate chain of cog wheels – much like granpa's watch. A sign of the times was the use of an enamelled retaining plate to hold the rubber cover over the motor. These actuators were first used on the S2 series cars and continued until the SZ in 1980 when a new design was introduced.

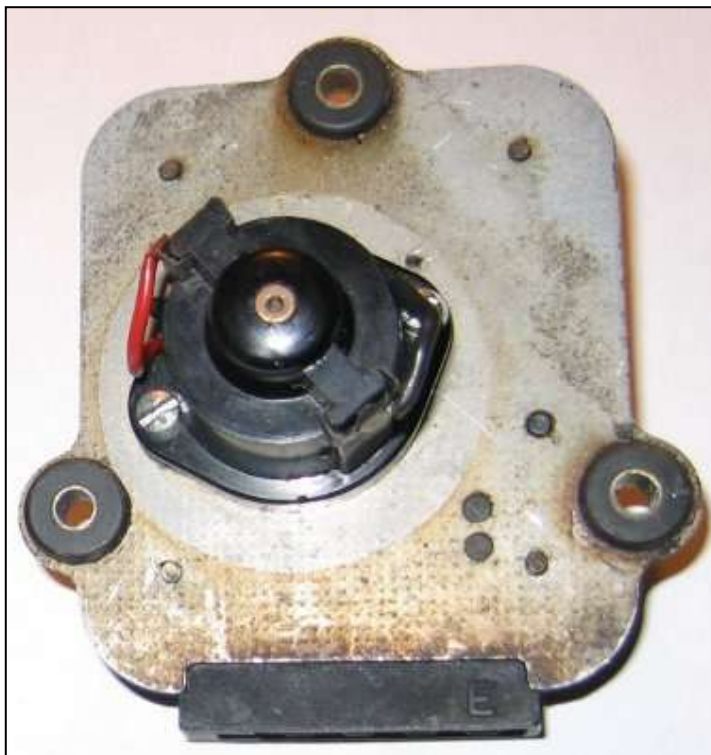
Here the motor cover has been removed exposing the little noise maker we are so familiar with. The tiny bronze bearing seen in the middle of the motor casing is an Oilite bush.

The bushes are made usually of powdered bronze which is compacted to shape and dimension required and then heated to permanently bond the particles together but at the same time leaving the interstices to be filled with oil. The bushes dry out and should be periodically re-lubricated.

Ideally the dry bush should be placed in engine oil (SAE 30) and heated to about 80°C for at least 15 minutes. The item is then plunged into cold oil (SAE30) until it has cooled off. The heat drives out air and the cold and contraction sucks the oil in – ingenious n'est pa? Clearly you leave the bush where it is and immerse the

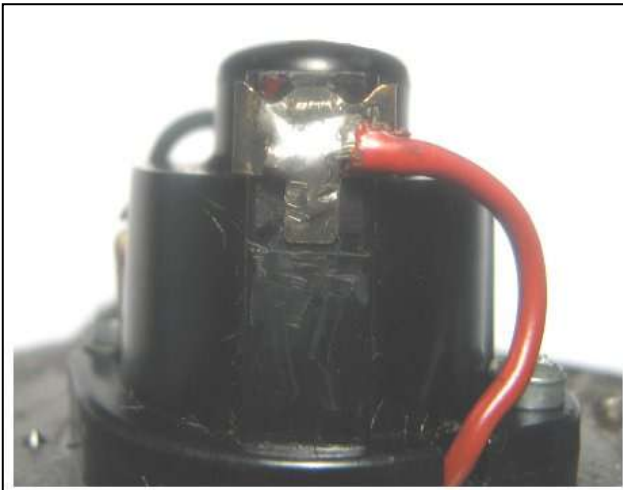
At left is the motor extracted after removing the two attaching screws seen here.

The small metal covers for the brushes can now slide up, releasing the brushes and springs. Be careful, they are very small and easily lost.

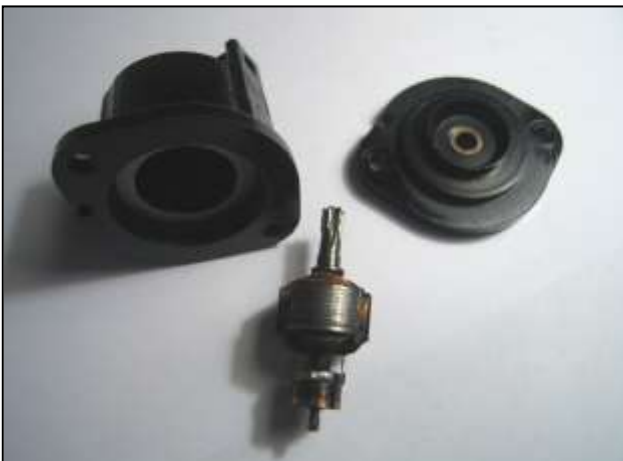
At left is the motor dismantled showing the armature and end plate. In the latter can be seen the other Oilite bush for the armature.

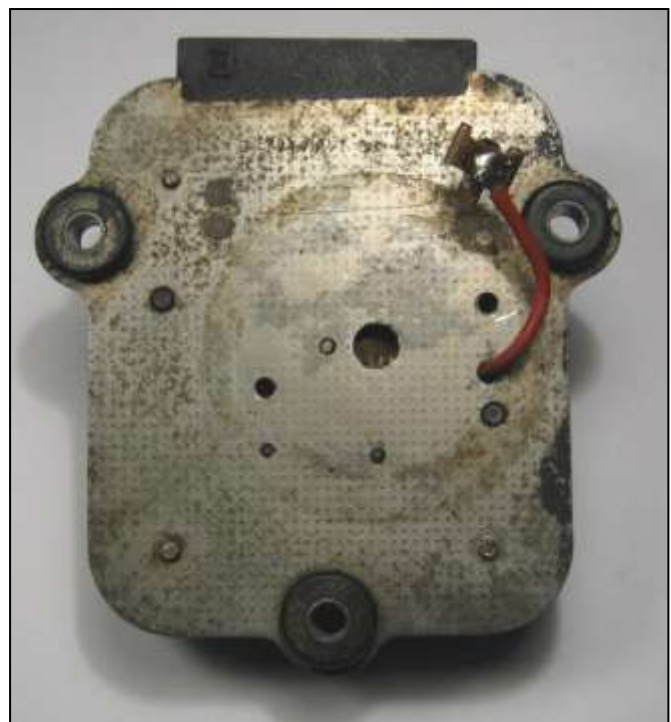
end shaft and gear. Also put a small amount of high melting point grease on the gear seen through the centre hole seen in the picture below.

This gear can be moved by turning the output shaft on the other side of the actuator body with your finger and thumb.
